From: Howard, Leslie Ann CIV USN BRAC PMO SAN CA (USA) [leslie.howard@navy.mil]
Sent: Thursday, January 21, 2021 12:57 PM
To: Stoick, Paul T CIV USN NAVFAC SW SAN CA (USA) [paul.stoick@navy.mil]
Subject: FW: HPNS Parcel E-2 Phase II Draft Final RACSR
Attachments: FINAL_RASCR_PE2_APPENDIX A.pdf;
FINAL_RASCR_PE2_TRACKED.doc

From: Howard, Leslie Ann CIV USN BRAC PMO SAN CA (USA)
Sent: Thursday, January 21, 2021 12:53 PM
To: Ueno, Karen <Ueno.Karen@epa.gov>; Bacey, Juanita@DTSC <Juanita.Bacey@dtsc.ca.gov>; White, Jeff@Waterboards <Jeff.White@Waterboards.ca.gov>; Low, Tina@Waterboards <Tina.Low@waterboards.ca.gov>; Brownell, Amy (DPH) <amy.brownell@sfdph.org>; Chesnutt, John <Chesnutt.John@epa.gov>; King, Nathan@Waterboards <Nathan.King@waterboards.ca.gov>
Cc: Robinson, Derek J CIV USN NAVFAC SW SAN CA (USA) <derek.j.robinson1@navy.mil>; Pauly, Brooks CIV USN BRAC PMO SAN CA (USA) <brooks.pauly@navy.mil>; Egan, Jamie <Jamie.Egan@jacobs.com>; Macchiarella, Thomas L CIV USN COMNAVFACENGCOM DC (USA) <thomas.macchiarella@navy.mil>
Subject: HPNS Parcel E-2 Phase II Draft Final RACSR

Response to Comments on the Draft <i>[Final]</i> Remedial Action Construction Summary Report, Parcel E-2 Pha

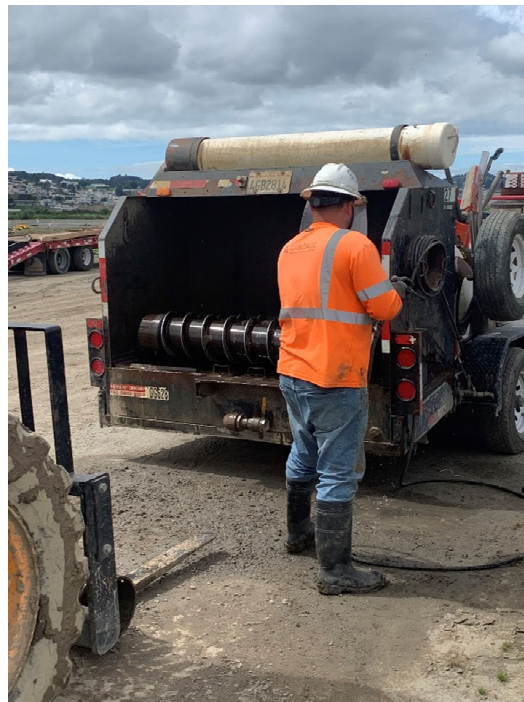
Cascade Drilling Performing Steam Cleaning of Drilling Augers during Installation of Upgradient Well Network Parcel E-2. April, 4 2019

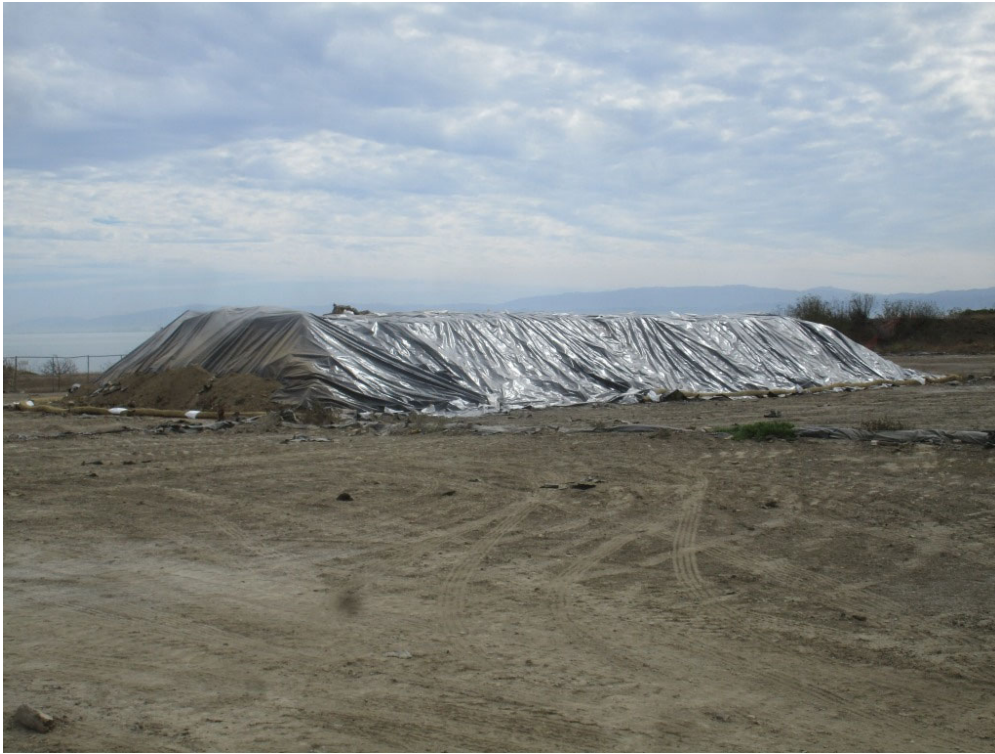
RCRA hazardous waste soil pile
Staged within the AOC on a raised RSY pad

RCRA soil pile tarped with plastic sheeting and bermed with straw wattle wrapped in plastic to prevent infiltration from run-on. October, 1 2018

from run-on. [as evidenced by the attached photographic documentation; Appendix A] All soil stockpiles on site were regularly inspected as part of the required BMP inspections and any deficiencies were noted and repaired as soon as practical. This process was maintained until the remedial waste soils and debris were properly transported, treated, and disposed of at US Ecology located in Beatty, NV. The weekly BMP inspection logs are currently stored with the project files and are not typically included as part of the RACSR; however, they may be provided as a separate submittal.
